Brian Ezyk
Sunny Farms Landfill LLC
12500 W Co Rd 18
Fostoria, Ohio 44830
Subject: Sunny Farms Landfill, Seneca County
Letter of Compliance

Municipal Solid Waste Landfill
Inspection Checklist

Facility/Location Name: Sunny Farms Landfill LLC

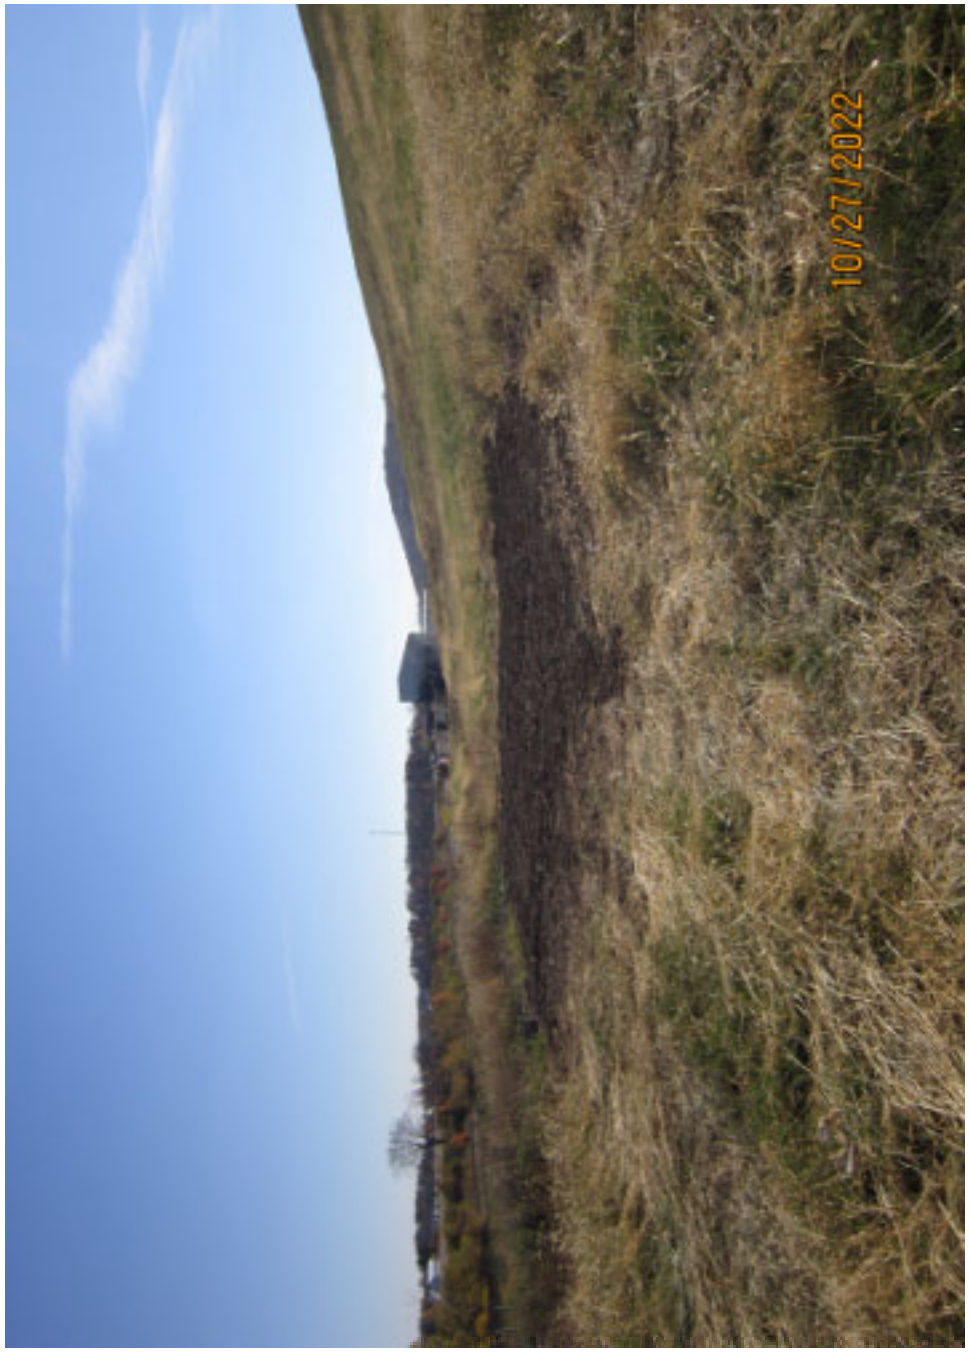
#	General Comments Section
	Broom truck was out cleaning road
	Cover looks good
	Working area small compact and defined. Observed wood material, paper material, tarps and cloth.
	Slope seeding 10-31-2022
	Cell 2 area recently filled with fresh soil shown in pictures, Area south of that location still has area that appears to be sunken in comparison to surrounding area. Please investigate.

Soil placement at cell 2
